The up-dated FTE Core Guidelines, valid as of 1 July 2021, define the process and acceptability criteria for the return of brake caliper cores.

Please study and refer to the below guidelines with photo examples of calipers not accepted. The following non-acceptance error types are used when the core is scrapped and mentioned on our paperwork because it cannot be accepted for remanufacturing process:

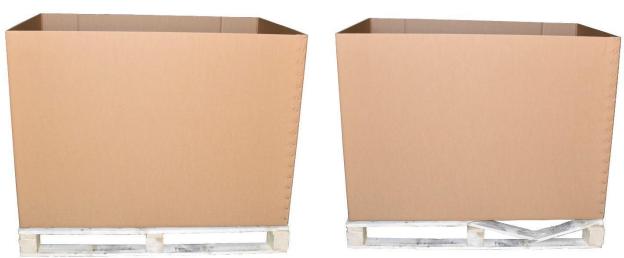
<u>Accepted dimensions included standard wooden euro pallet with</u> the lid on

Maximum height = 1050 mm

Depth = 800 mm

Width = 1200 mm

DO NOT use one time / broken pallet or without the lid due to the safety risks

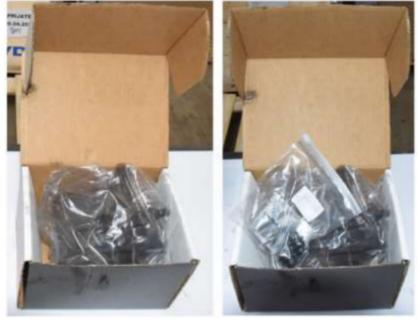
Original packaging

<u>Acceptable</u>

Only FTE boxes are accepted and FTE validated customer boxes.

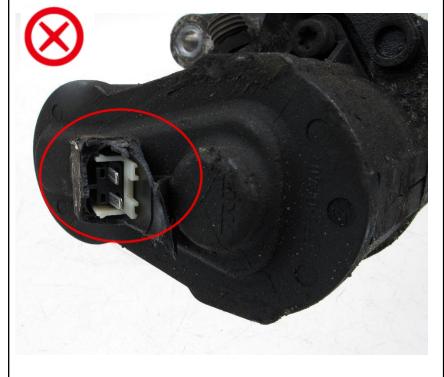
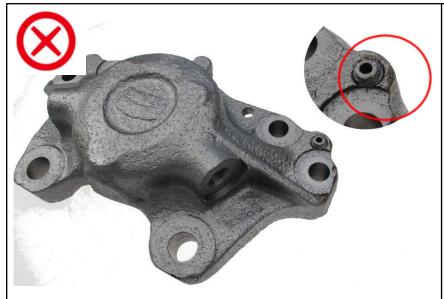
Broken core / unauthorised repair

Not acceptable

Any damages or defects to the electrical motor and or the connections on the electrical handbrakes are not acceptable.

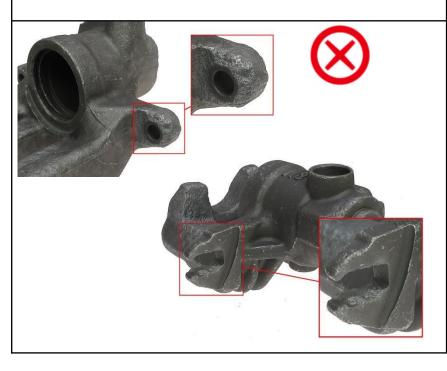
Not acceptable

Broken bleeder screw hole (NB Double check)

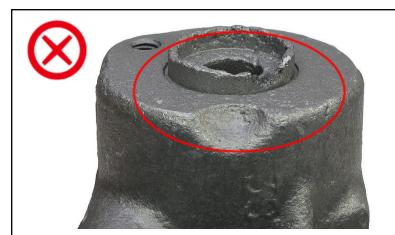
Corrosion

Not acceptable

High level of corrosion on the connection surface for the guide pin

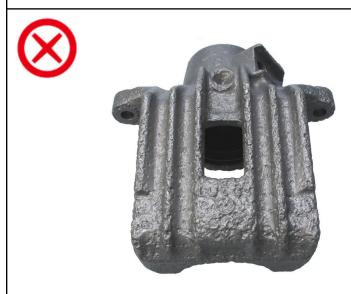
Corrosion

Not acceptable

The surface is corroded and the core cannot be used for remanufacturing.

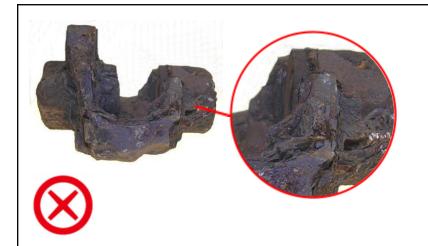
Corrosion

Not acceptable

Severe corrosion all over the core housing. General areas are corroded to a point where they are almost non-existent leaving the core not remanufactureable

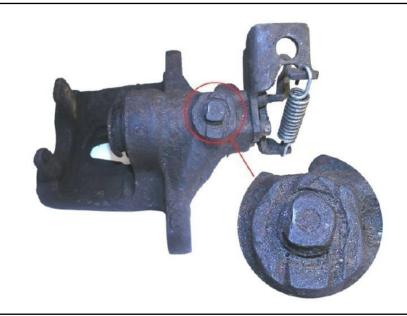
Corrosion

Not acceptable

Extreme corrosion.

Where the contact surfaces for the brake-pads are corroded to a point where they are non-existent.

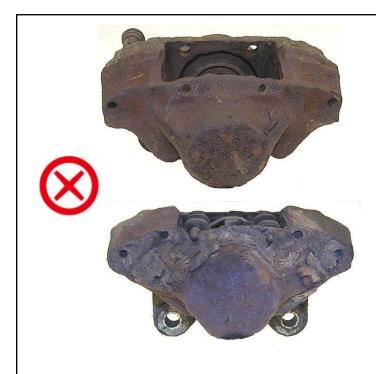
Broken core / unauthorised repair

Not acceptable

Unauthorised repair.

A bolt has been inserted, the thread is damaged and traces of machine operation are visible.

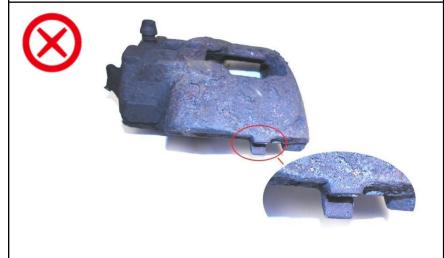
Corrosion

Not acceptable

Severe corrosion all over the core housings e.g. pin holes, surface for brake pads. These areas are corroded to a point where they are almost non-existent and the core cannot be used in remanufacturing.

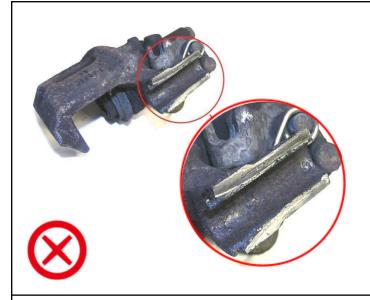
Broken core / unauthorised repair

Not acceptable

Fragile caliper.

The support for the clips is broken and the core cannot be remanufactured.

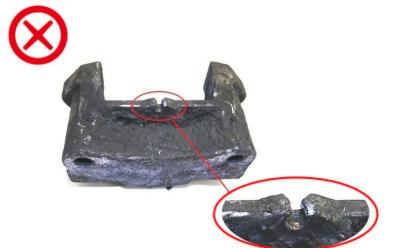
Broken core / unauthorised repair

Not acceptable

Severe damage. Faulty dismantling or similar. Part of the housing has been cut off.

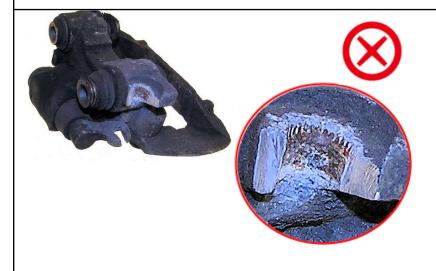
Broken core / unauthorised repair

Not acceptable

Severe damage.

The clip support is broken. (Eye for the guide pin).

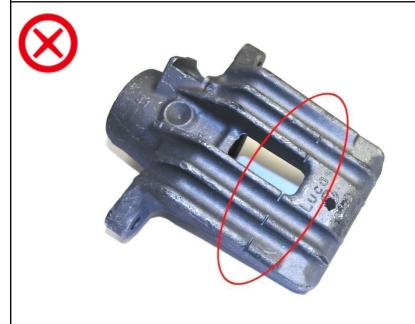
Broken core / unauthorised repair

Not acceptable

Severe damage. Part of the caliper housing is broken. (Guide pin hole)

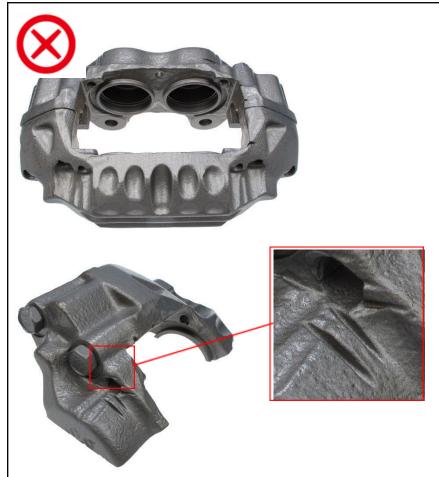
Broken core / unauthorised repair

Not acceptable

Unauthorised "repair" construction change. Saw marks across the caliper housing.

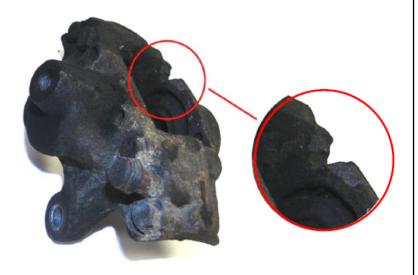
Broken core / unauthorised repair

Not acceptable

Severe damage. Part of the housing is broken. (Eye for fixing bolt).
